TRIAL REPORT

SUBJECT : Thompson Coupling , TCAE-2
Location : PT. Pindo Deli pulp and paper Tbk. / Kerawang mill
PM10, Waste Water Pump no 2 motor 123317102MP
Dated : 03/03/2015
Problem : High Vibration, Coupling failure/ brake (brand, Normex148)

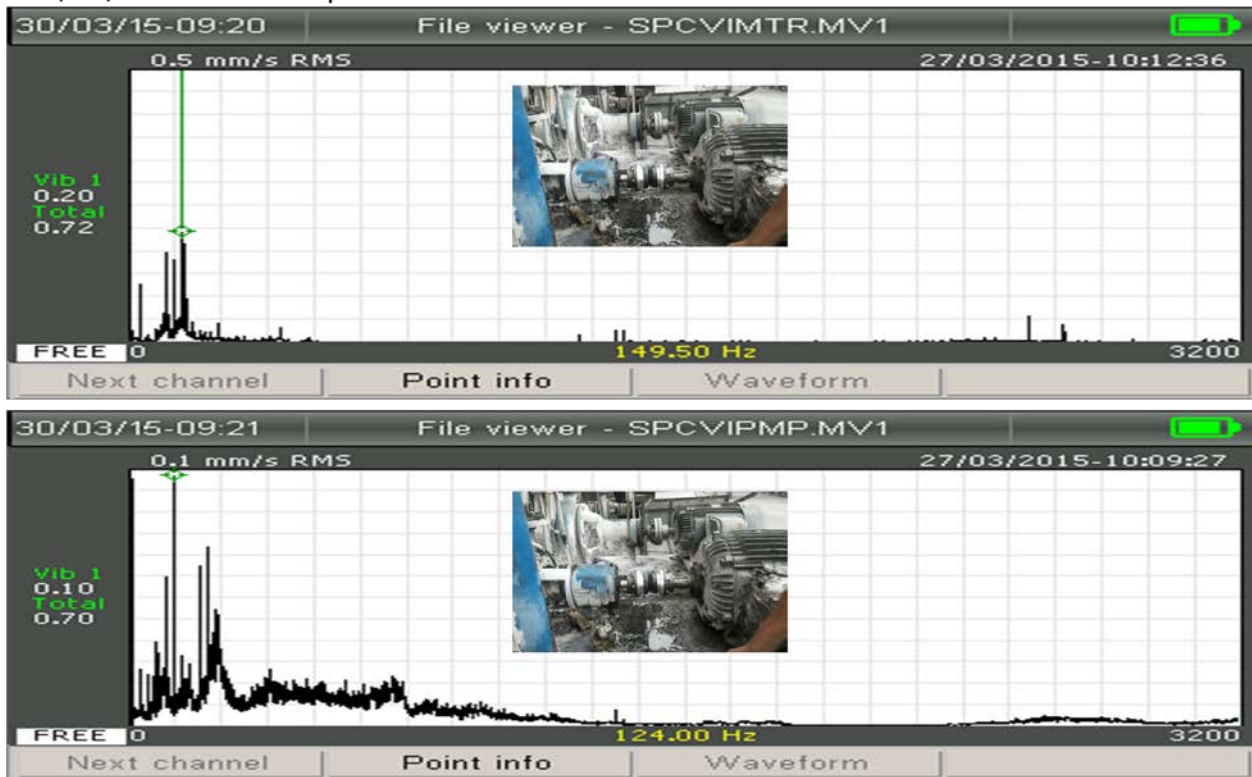
Monitoring vibration
27/03/15 motor-Pump inboard

No high vibration detected, value vibration 0.5 & 0.1mm/sec
No indicated misalignment detected.
(Thompson coupling installed without any alignment tools or Laser alignment)
